**MISSISSIPPI-SALT-QUINCY RIVER BASIN**

C & A LAKE DAM  
AUDRAIN COUNTY, MISSOURI  
MO. 10105

**PHASE I INSPECTION REPORT**  
**NATIONAL DAM SAFETY PROGRAM**

DECEMBER 1979

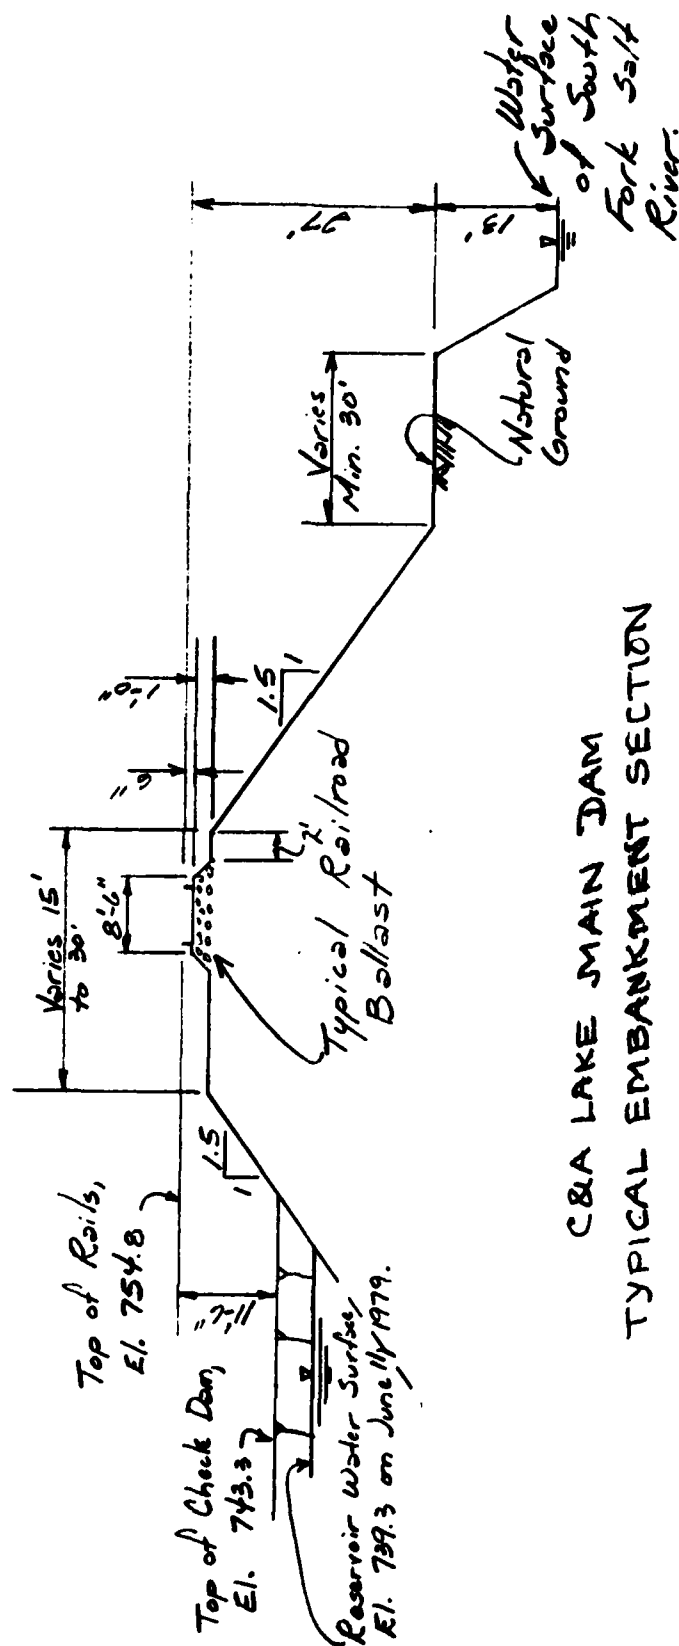
C&A LAKE MAIN DAM  
TYPICAL EMBANKMENT SECTION

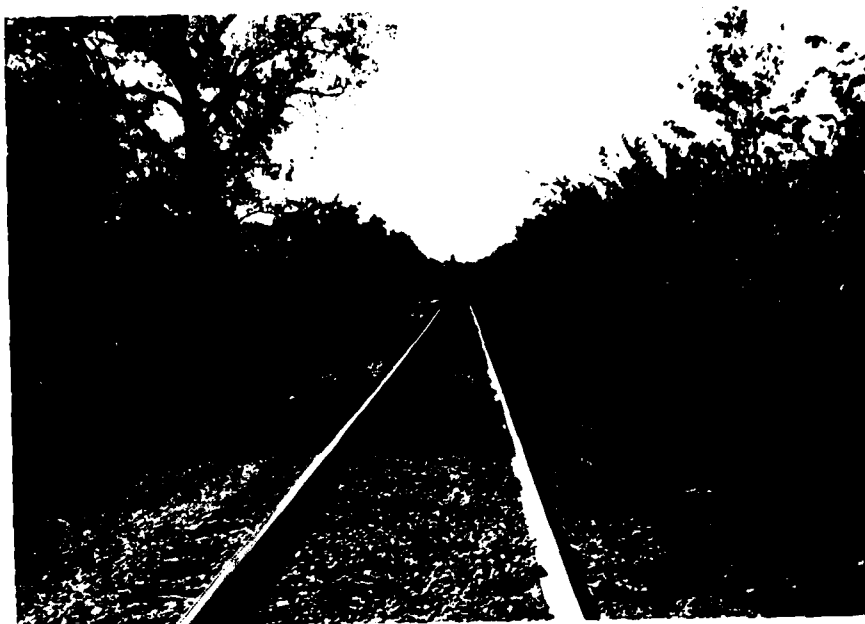
protected by cinders. No evidence of settlement was observed along the crest. No cracks were observed.

Photo D1 - View of the crest.

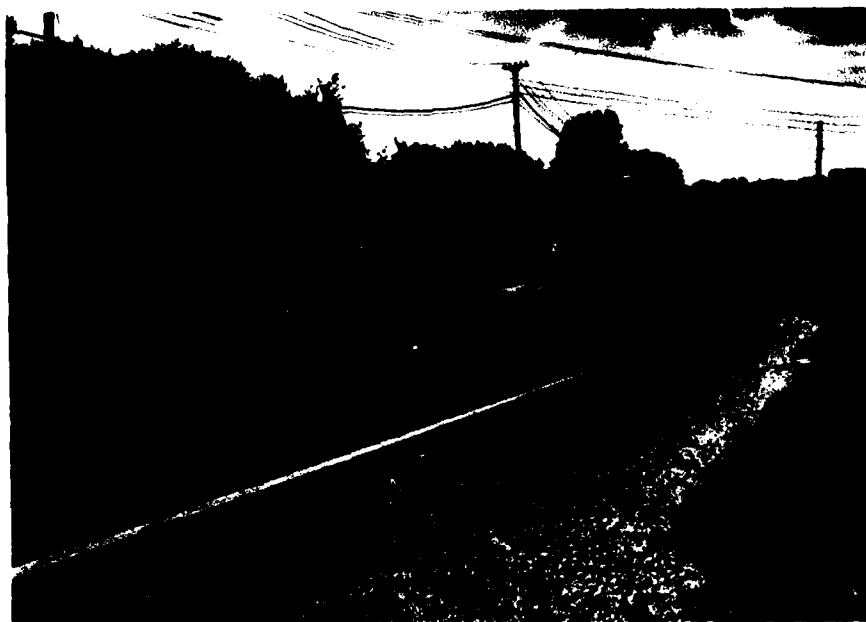
Photo D4 - View of the railroad bridge over U.S. Highway 54.
